Orpheum Theatre Terra Cotta/Masonry Restoration

Hennepin Avenue
Minneapolis, Minnesota

Building Management Report

July 25, 2003

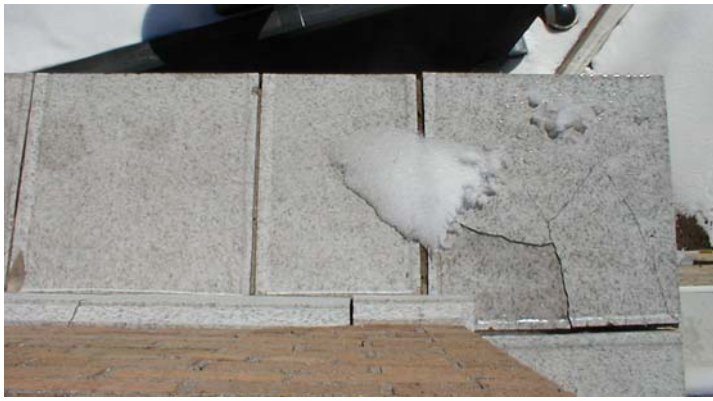
Fig.1: Terra cotta cornice at southwest corner of South Tower .

- Terra cotta: At this time, based on observations made during the fall of 2002, we are recommending in place repair of corner units. One unit, however, demonstrates a higher degree of damage than the others. There is a large horizontal crack running the length of the unit (Details 34B, 40A, 40.2A/4-9). A physical inspection made during the fall of 2002 indicated that the unit was solidly anchored to the wall although the continued stability of this piece remains of some concern. The horizontal crack aligns with the support steel and it is possible that, with advanced deterioration, the lower half of the unit could easily free itself from the steel supports and fall to the

sidewalk below. Based on observations made during the fall of 2002, and as a measure to conserve budget, we are currently recommending in place repair of this unit but only after stability is critically evaluated and assured. The repair should include mechanical fasteners that tie the separated bottom piece to solid steel or masonry substrate. This unit will most likely need replacement in the future.

- This severely cracked and displaced terra cotta unit shows more advanced deterioration than is seen at more representative conditions at other corner cornice units.

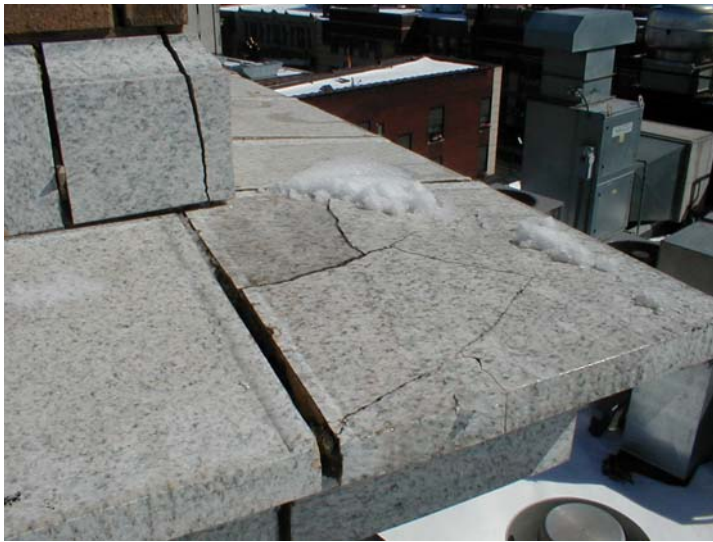
Fig.2: Terra cotta cornice and band at southwest corner of South Tower .

- The corner unit of the horizontal band above the corner unit is also cracked and displaced. The location of the damaged terra cotta corresponds directly to deteriorated masonry and steel shown in Figs. 4-8. The most likely scenario is that long term water penetration from leaky parapet coping and flashing started the deterioration process at this corner.

Although the coping was repaired in 1992, the masonry and terra cotta joints were left open and water continued to infiltrate the wall system. Lack of maintenance has contributed significantly to the accelerated deterioration and potential failure at this location.

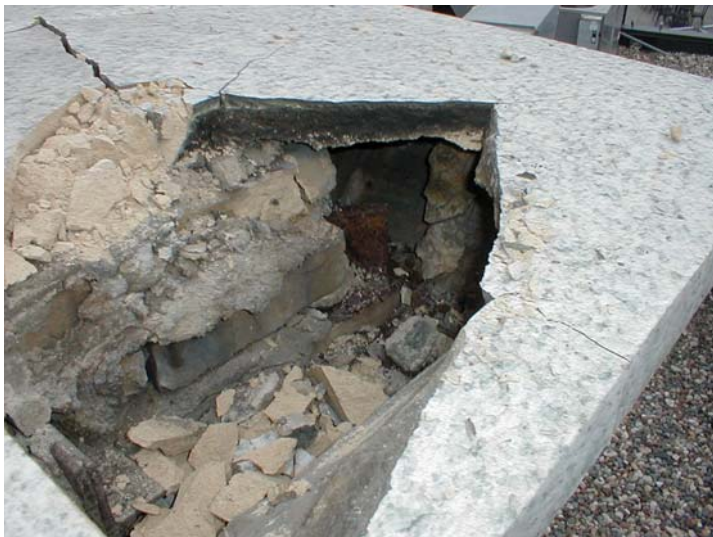
Fig.3: Terra cotta cornice after selective demolition.

- This unit was sacrificed in order to provide the architect and structural engineer access to the structural steel supporting the cornice. We discovered that the ends of this unit were open, probably to allow masons access during installation. These open ended units allow water penetrating the terra cotta joints to flow directly onto steel supports within the interior cavity. We suspect that all of the corner units are open ended and therefore much more susceptible to the effects of water infiltration.

Although corroded, the lookout support angles appear to be well anchored and structurally sound.

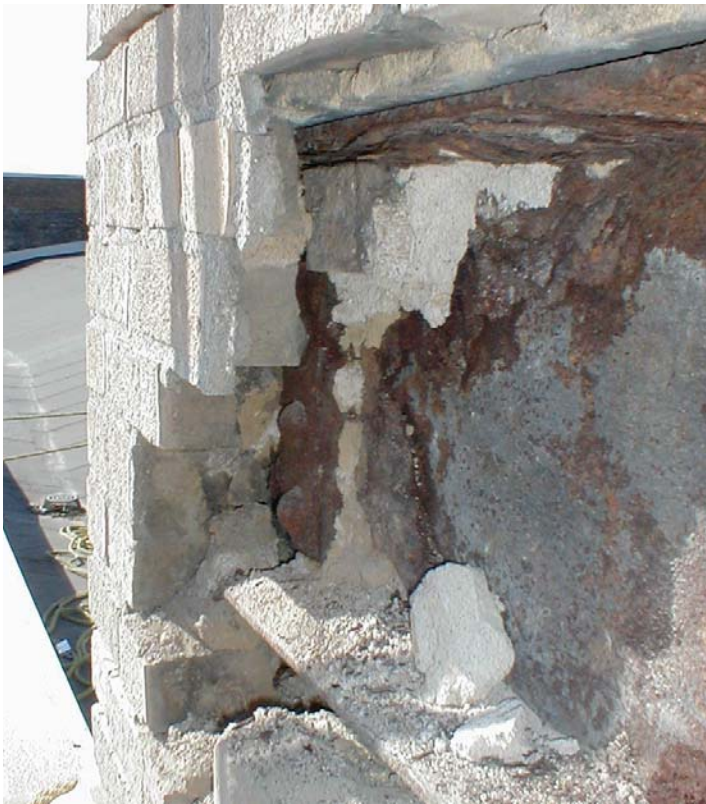
Fig.4: Exposed column connection at southwest corner of South Tower immediately above the terra cotta cornice.

- Top flange of structural steel beam is severely corroded. Delamination is evident across the entire length of the beam with rust jacking measuring 1"-1.5" thick.
- Exterior face of the web is severely corroded. In the original configuration, face brick was cut to fit around the beam flanges and the space between masonry and steel is grouted solid. Rust jacking at the web exerts tremendous force on the grout within the cavity breaking mortar bonds and displacing the brick masonry. Brick masonry was loose to the touch and could be easily removed by hand where forced away from the beam.

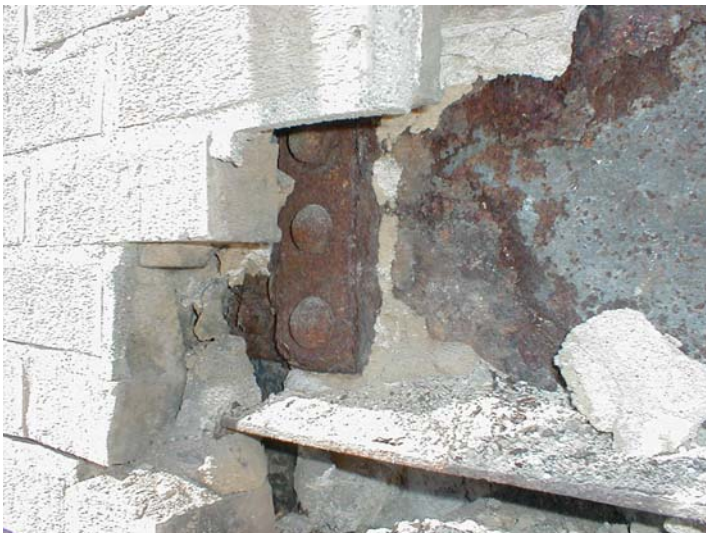
Fig.5: Partially exposed column connection at southwest corner of South Tower immediately above the terra cotta cornice.

- Riveted column connection appears to be structurally adequate. RFP#1 suggests a solution that provides additional support at the connection as a safeguard against continued corrosion.

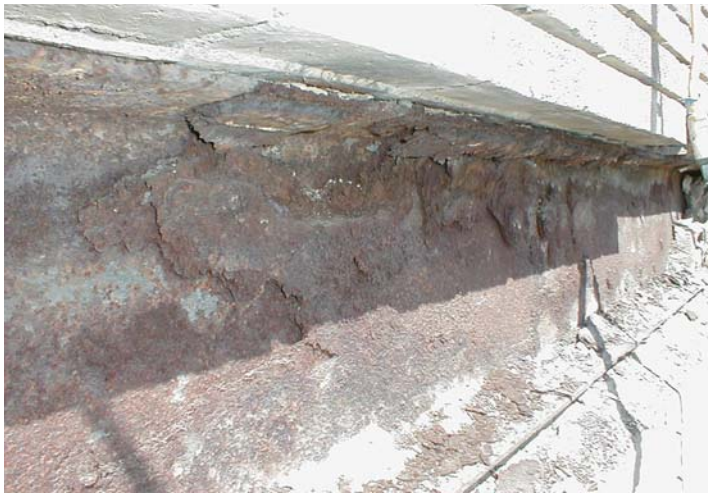
Fig.6: Exposed beam at south face of South Tower immediately above the terra cotta cornice.

- Top flange of steel beam is severely corroded. Delamination is evident across the entire length with rust jacking measuring 1”-1.5” thick.

- Exterior face of the web is severely corroded along the entire length of the beam. Test holes were drilled through the beam web in order to determine current thicknesses. Measurements from a number of locations were taken in order to determine the remaining overall structural capacity of the beam. It was determined that the beam had deteriorated to a point where its structural integrity was questionable. We propose a solution to reinforce the beam in RFP #1.

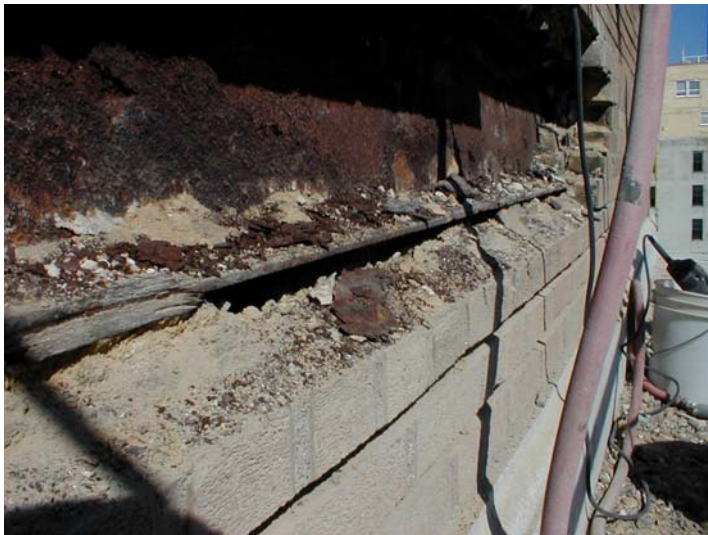
Fig.7: Exposed beam at south face of South Tower immediately above the terra cotta cornice.

- Steel corrosion at the bottom flange appears less severe.

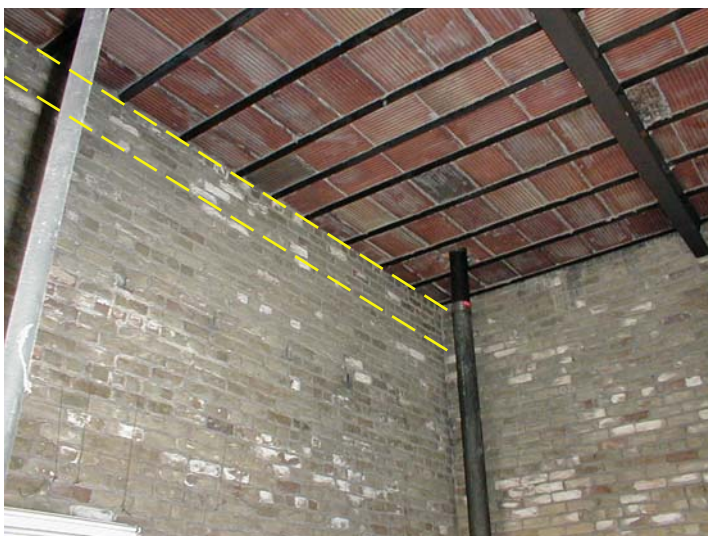
Fig.8: Interior face of south face of South Tower with approximate beam location indicated.

- The interior face of the wall, corresponding to the location of the beam shown in Figures 1-4, shows no signs of water damage. There are no damp areas, no masonry staining or rust streaking, no efflorescence, and no open joints or displaced masonry units. This is encouraging considering the conditions seen on the exterior face.

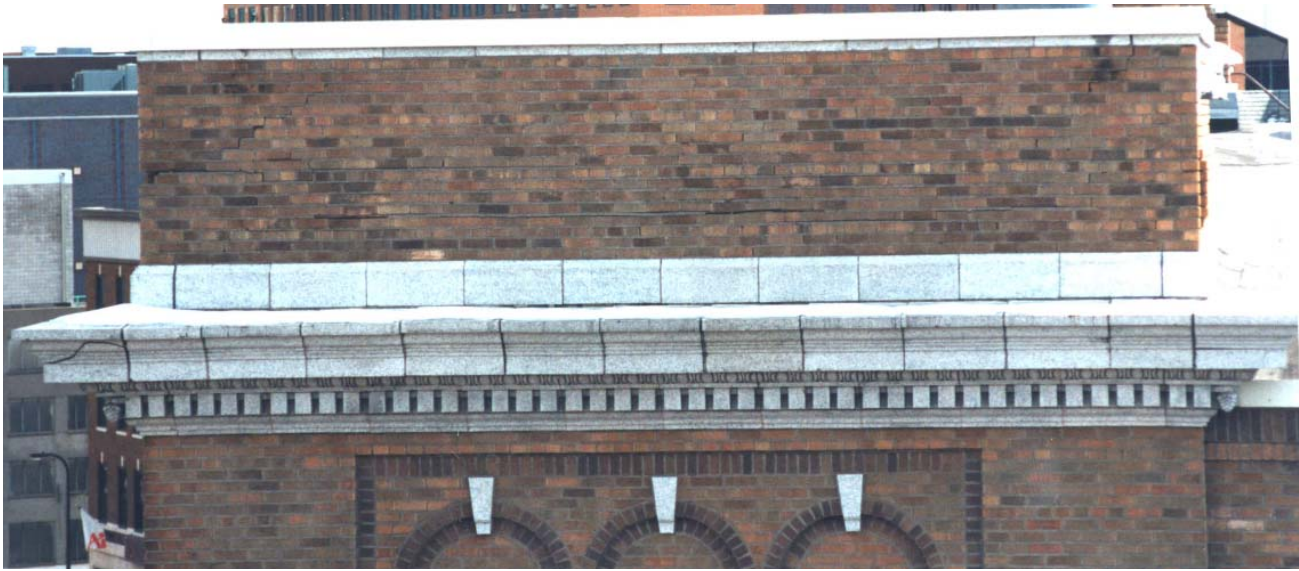
Fig.9: North elevation at North Tower showing condition of brick masonry above the terra cotta cornice.

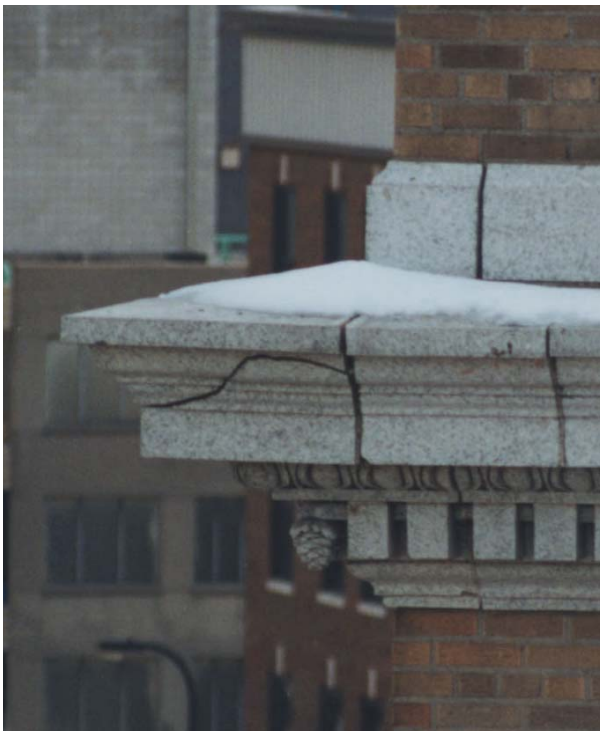
Fig.10: Enlarged detail of terra cotta corner unit at north elevation at North Tower showing large horizontal crack.

- The terra cotta corner unit was evaluated by the contractor in the fall of 2002. It appears to be solidly anchored although the severe horizontal crack is a continuing concern. The stability of the bottom half of this unit should be reassessed and, as a precautionary measure against continued degradation, mechanically anchored. This piece will eventually need replacement.
- Brick masonry above the cornice has open horizontal joints corresponding to the top and bottom flange of the perimeter roof support beam. Masonry is bowed and presumed to be loose. Diagonal cracks at both corners are also visible.
- Steel corrosion is visible at open joints. The integrity of the structural beam is presumed to be compromised and in need of repair or perhaps even replacement.

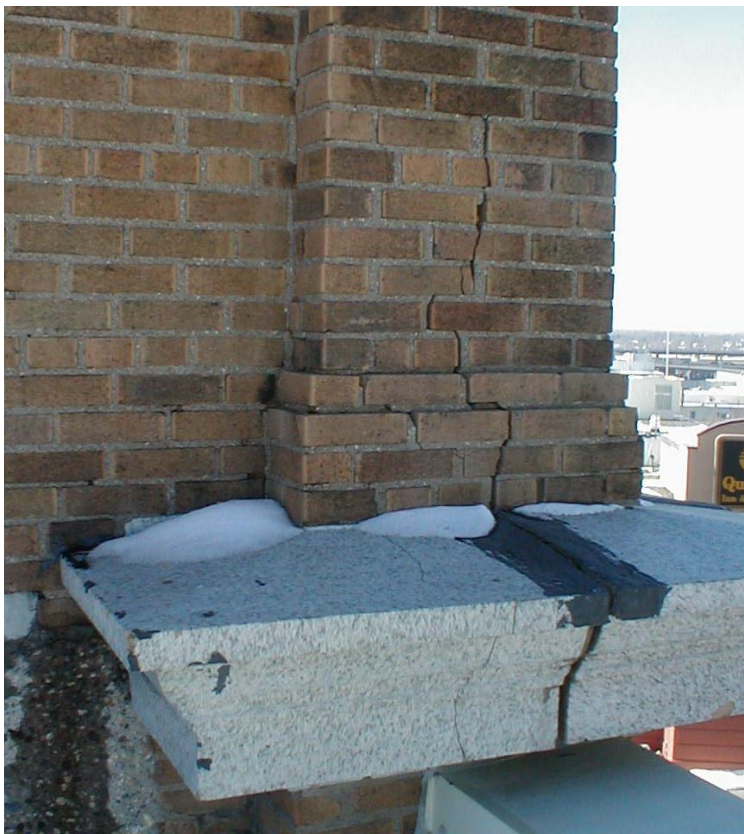
- Vertical crack through mortar and brick masonry at east face of pier is aligned with the terra cotta joint at the cornice. Movement at the corner has caused large open joints between units. An old repair using some kind of bituminous compound has further damaged the terra cotta units.
- Another significant vertical crack, visible at the inside corner of pilaster, allows more water to enter the wall system.
- Additional masonry and mortar cracking is visible around the corner on the north facade.

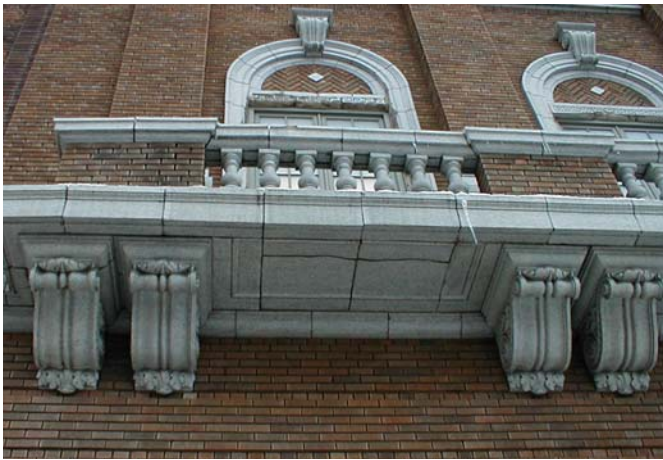
Fig.12: Balcony Bay 1 (south end) with cracked soffit units, April 2002.

- Terra cotta damage is most likely due to excessive water penetration at the brick masonry pier (See Figs. 15-18)and from a blocked balcony floor drain. Steel anchorage in this area was found to be extremely corroded (See Figs. 19- 24). Resulting rustjacking forces have caused a number of adjacent terra cotta units to shatter. For example, observable damage to the soffit units is presumably due to forces resulting from corrosion of a horizontal pin located immediately above the large soffit cracks. (See Detail 1/5.1 included in this report)

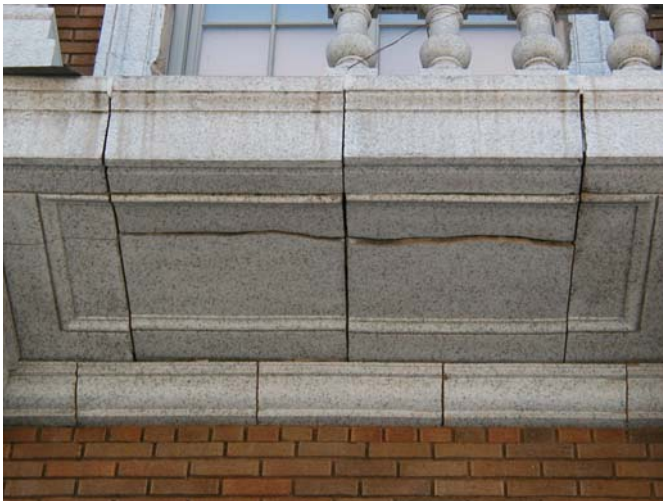
Fig.13: Balcony Bay 1 (south end) with displaced soffit unit, May 2003.

- Then terra cotta soffit unit to the right has dropped nearly 3/4" over the winter causing concern for the overall stability of the back half of these units.

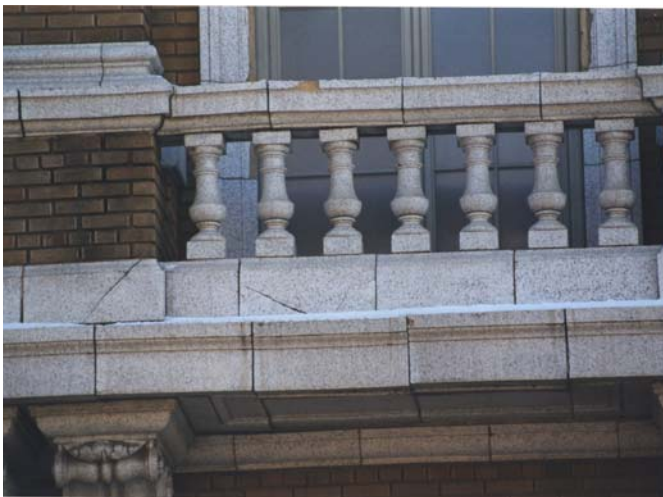
Fig.14: Balcony Bay 1 (south end) showing damaged terra cotta.

- Severe terra cotta damage is limited to areas adjacent to the water-damaged masonry pier. The baluster rail, showing significant vertical deflection, is very unstable and can be easily displaced laterally by simply pushing on it.

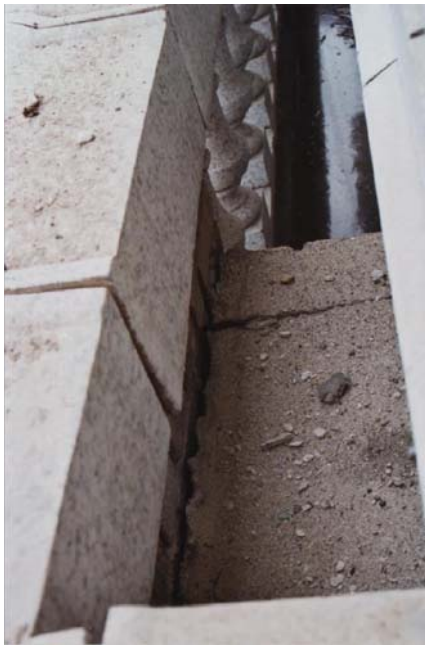
Fig.15: Balcony Bay 1 (south end) showing the flat recessed top surface of the masonry pier.

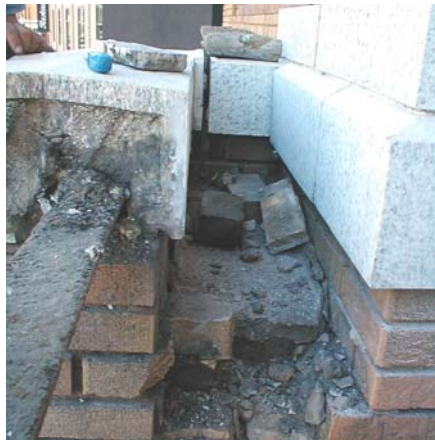
Fig.16: Balcony Bay 6 (north end) showing a similar flat recessed top surface and a thin layer of concrete to provide protection and improve drainage.

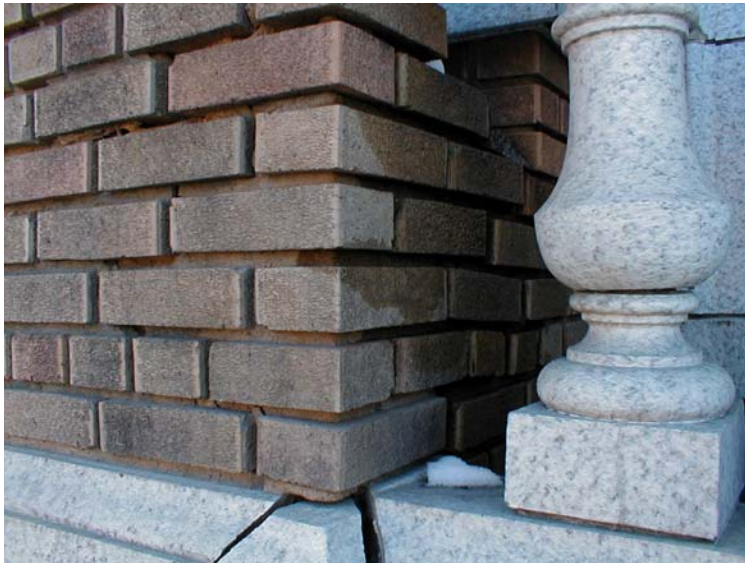
Fig.17: Balcony Bay 1 (south end) .

- Water saturating the exposed horizontal surfaces of flat recessed top penetrates deeply into the lower section of the pier through open mortar joints or runs down the face of the masonry pier. Water eventually reaches the steel anchorage system supporting the terra cotta. We suspect that cantilevered structural steel supporting the balcony itself may also be deteriorated to some degree.

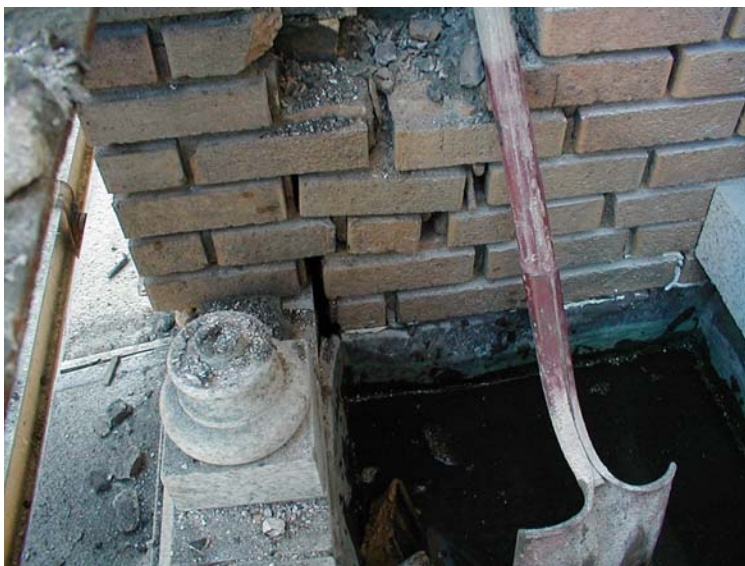
- Repeated freeze/thaw cycles and constant water flow patterns have eroded both mortar and masonry. Wide open joints allow excessive water penetration into the masonry assembly which in turn causes deterioration of steel anchorage buried in the system. The recessed flat portion will be flashed with metal and the pier rebuilt and repointed once steel and terra cotta repairs are made.

Fig.18: Balcony Bay 1 (south end) showing effects of long term water damage.

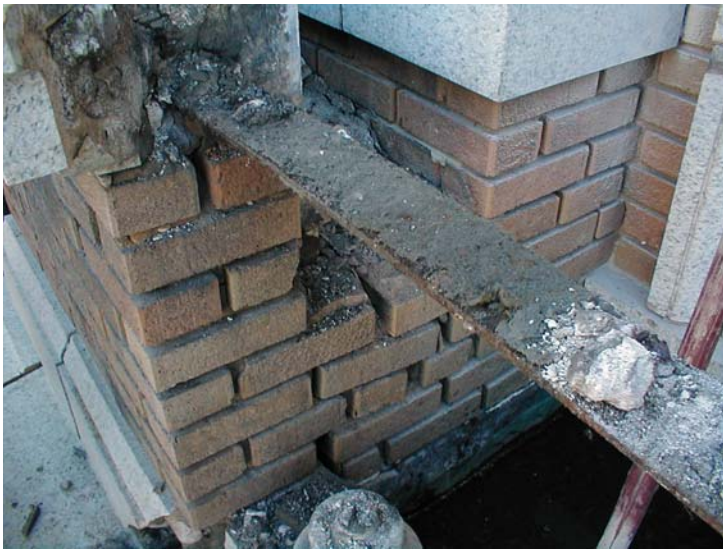
- The terra cotta baluster top rail is supported on a 3" x 1/4" continuous steel plate anchored at the ends by 5/8" vertical rods embedded in the masonry piers. Masonry joints between rail units and balusters were typically found to be open leaving the steel plate exposed. Delaminated sections of the corroded plate had measured thicknesses up to 3/8".

The balustrade was extremely unstable this entire section was dismantled by hand with little effort.

Fig.19: Balcony Bay 1 (south end) showing steel support for terra cotta baluster top rail.

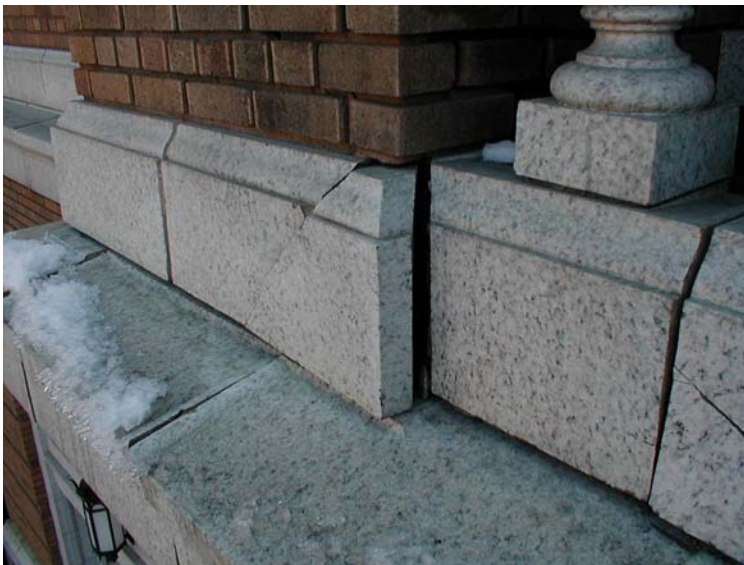
- Terra cotta is shattering as a result of increasing stresses from steel corrosion. Large open cracks provide additional avenues for direct water penetration. Snow and ice infiltrate and accumulate around the baluster toe rail. Repeated freeze/thaw cycles, in combination with the effects of rustjacking of steel supports below, cause the balustrade to heave upwards adding additional stress to the system. This movement breaks down the mortar joints between terra cotta units thus allowing even more water to enter the system. The cycle continues and degradation of both terra cotta and steel accelerates.

Fig. 20: Balcony Bay 1 (south end) showing fractured terra cotta baluster bottom rail.

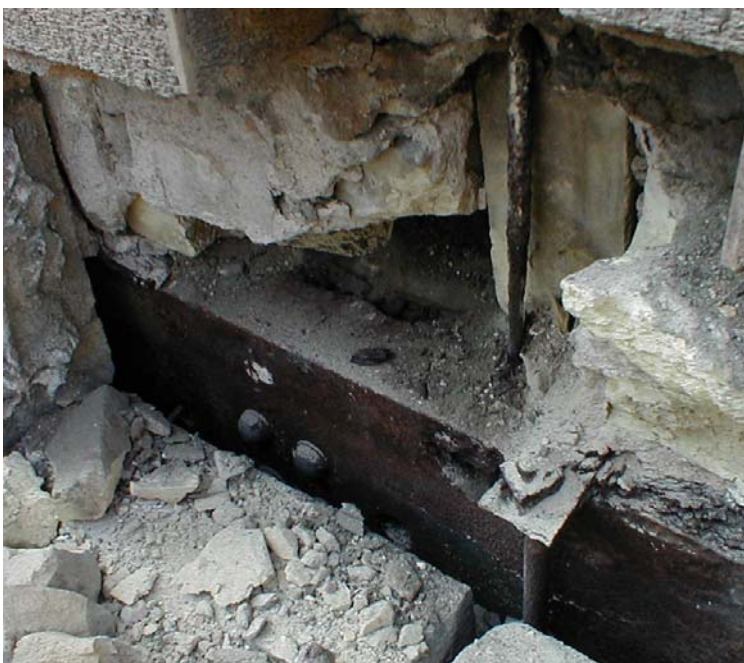
- The broken terra cotta band unit at the base of the pier was removed to provide access to buried steel supports. The severely corroded vertical rod represents the lower portion of the anchor support for the baluster top rail. Originally 5/8" thick, it measured less than 1/8" thick in some areas and was brittle enough to break by hand. Extreme delamination (1"-1-3/4" thick) of the top surface of the primary structural support channel can be seen to the right. The steel strap clipped to the channel and the 1/2" vertical rod it supports are also seriously corroded and in need of replacement. Dripstone Z-anchors were either missing or could be removed by hand.

Fig.21: Balcony Bay 1 (south end) showing steel support for terra cotta baluster bottom rail.

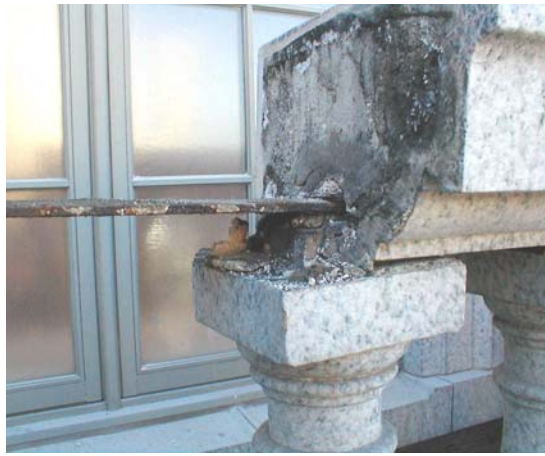
Fig.22: Balcony Bay 1 (south end) showing steel support plate for terra cotta baluster top rail at intermediate pier.

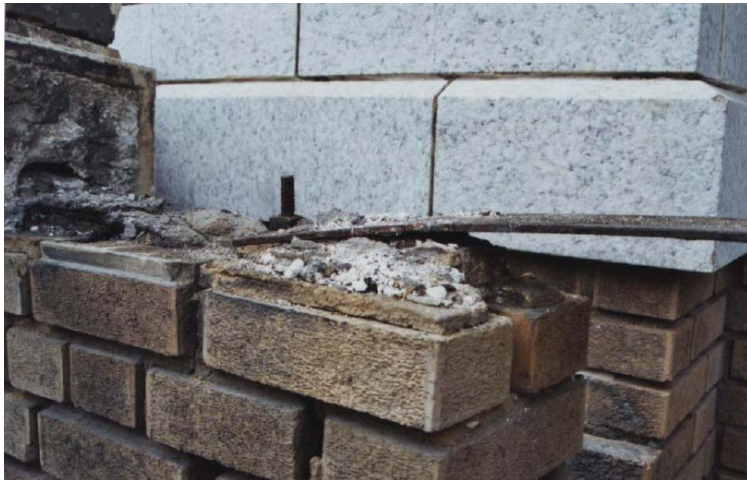
- Stresses from rustjacking and upheaval of the baluster rail system from below have caused deformation of the steel plate. The displacement ranges from 1-1/2"-1-3/4".

Fig.23: Balcony Bay 1 (south end) showing steel support plate and top of embedded vertical rod anchor for terra cotta baluster top rail.

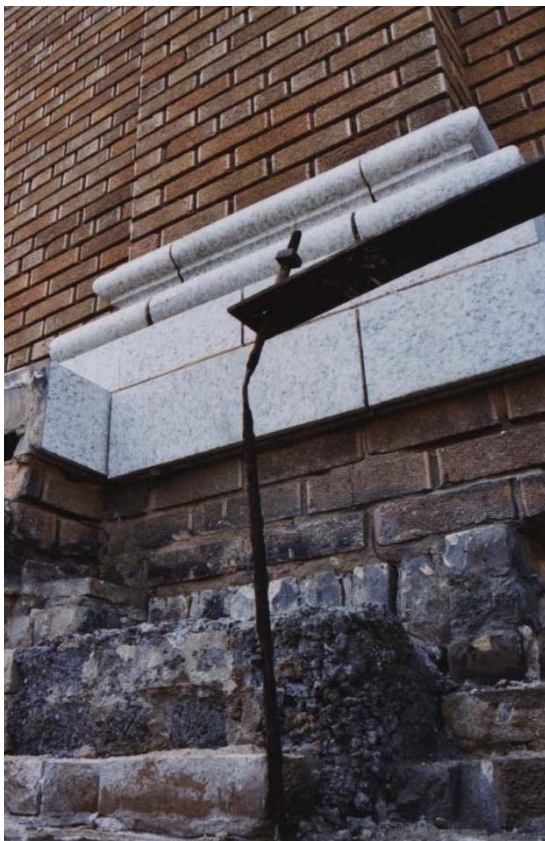
- The deteriorated masonry pier was deconstructed to provide access to buried steel supports. The severely corroded vertical rod is the main support for the baluster top rail. Originally 5/8" thick, it measured less than 1/8" thick at various locations and was brittle enough to break by hand.

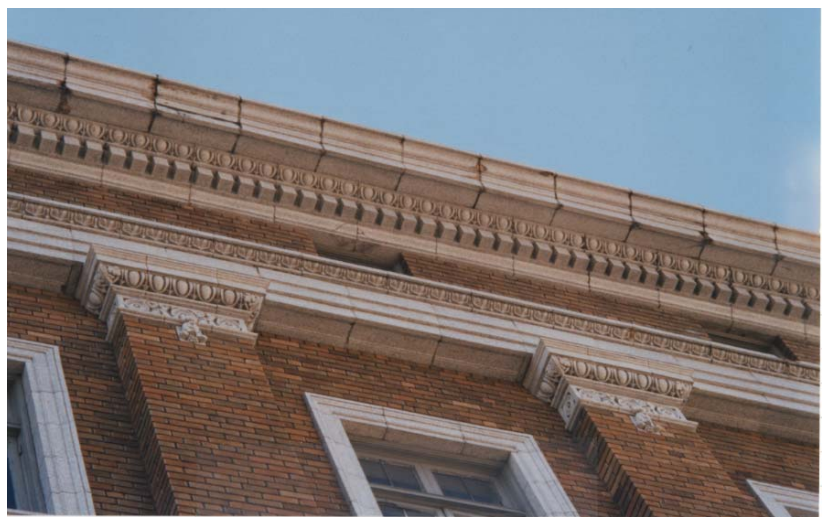
Fig.25: Damaged terra cotta cornice units along 9th Street main cornice viewed from below.

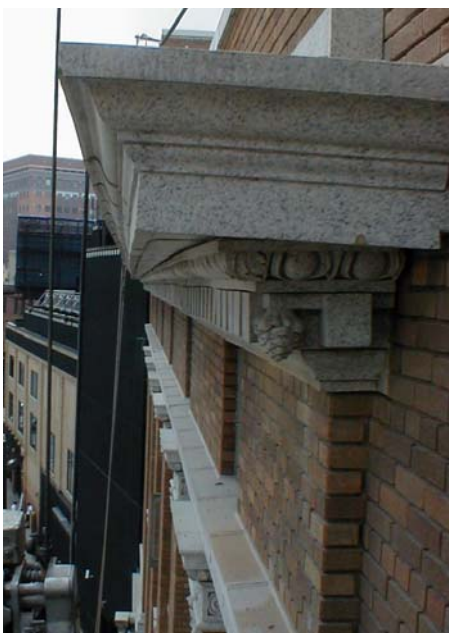
Fig.28: Terra cotta cornice along 9th Street

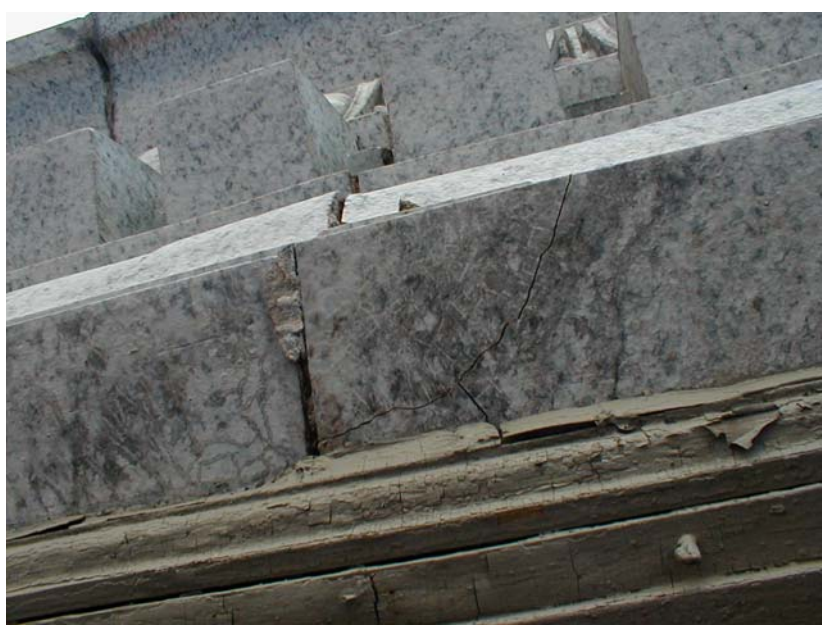
Fig.27: Damaged terra cotta bottom band cornice unit above third floor window

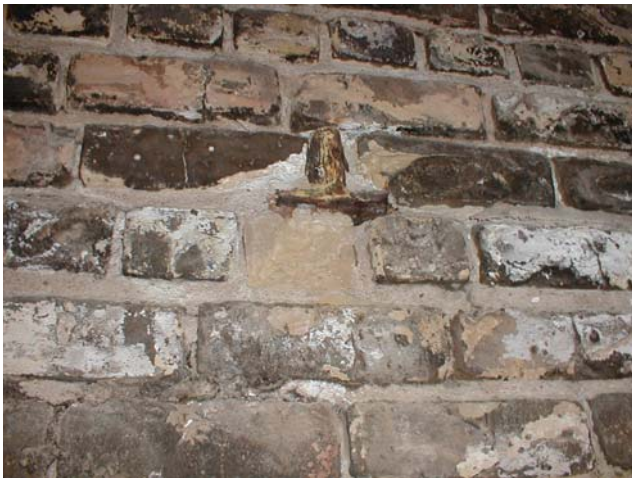
Fig.29: Corroded steel angles, presumably serving as primary structural support for the 9th Street main cornice, can be seen where damaged plaster has fallen away from the interior face of the wall.

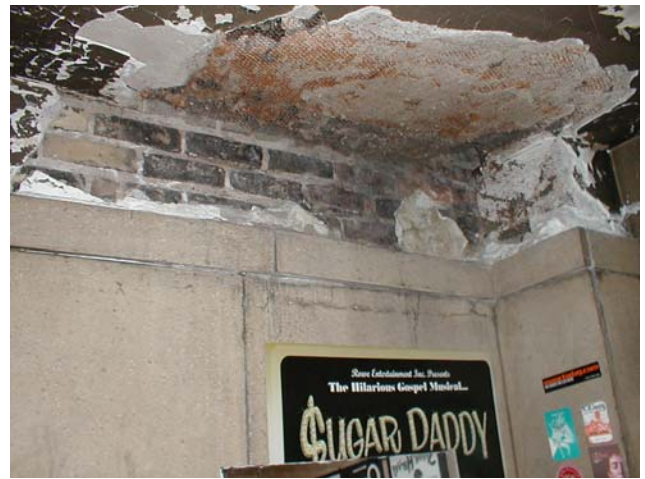
Fig.30: Old interior water damage from leaking tile roof and gutter detail.

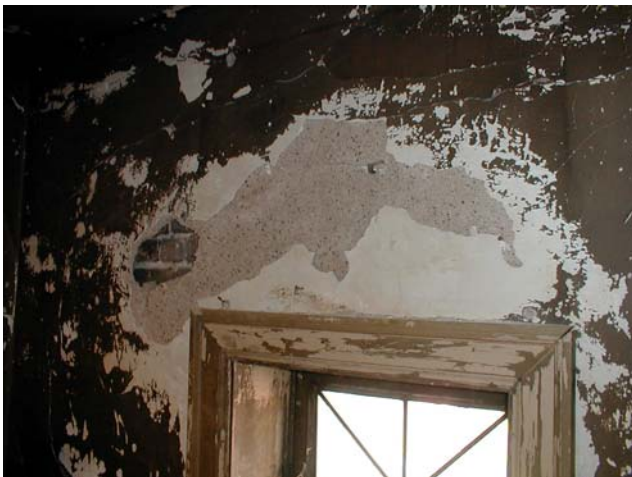
Fig.31: Old interior water damage from leaking tile roof and gutter detail. Terra cotta cornice and lintel units above this particular window are cracked.

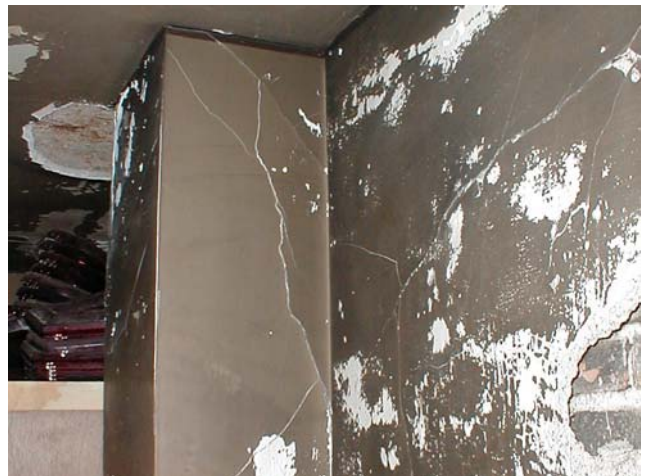
Fig.32: Old interior water damage from leaking tile roof and gutter detail showing extent of damage.

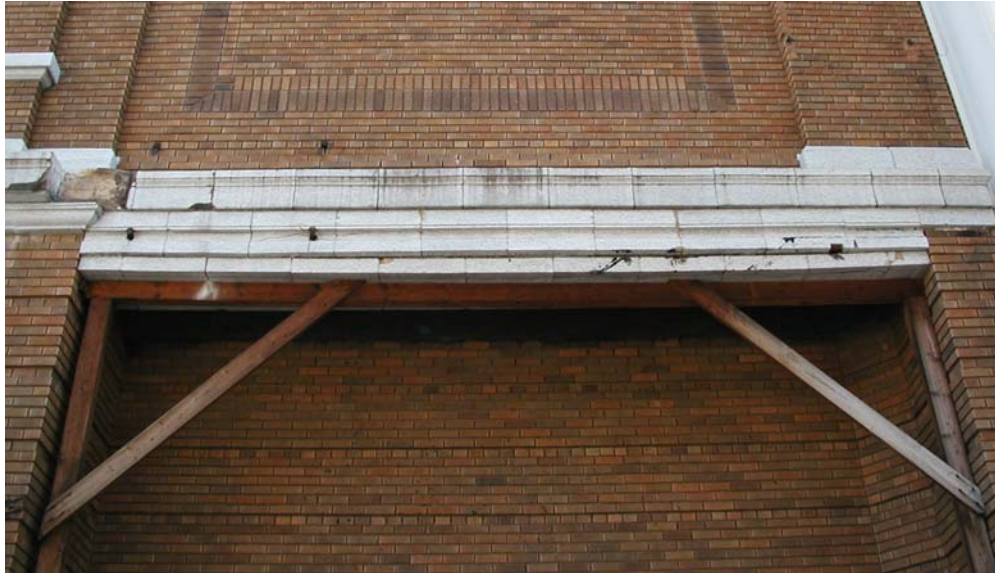
Fig.33: Projecting lintel at Hawthorne Avenue elevation braced on wood timbers. The temporary supports date back to the 1992 renovation.

The terra cotta should be removed to verify the configuration and condition of the structural support. Based on the visible indications of steel damage and the poor condition of the supported terra cotta, it is likely that the structural support for the lintel will require substantial reinforcement or replacement prior to repair or replacement of the terra cotta. Material and structural design services for replacement steel were not part of the bid package. Design requirements will be clarified after further investigation once the existing condition is dismantled.

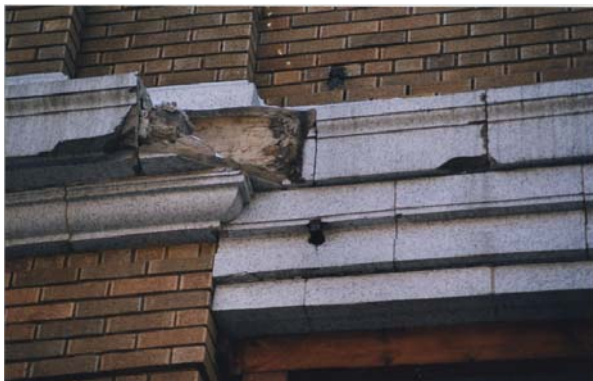
Fig.34: Corner of projecting lintel at Hawthorne Avenue.

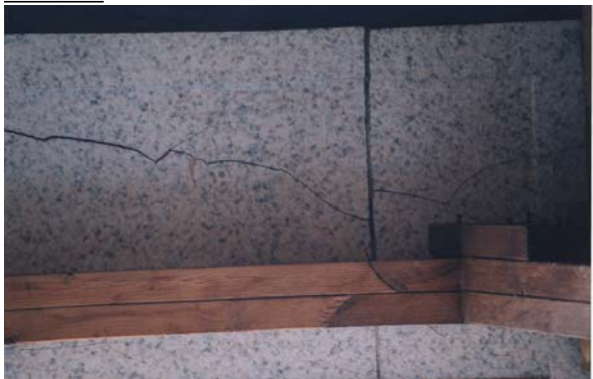
Fig.35: Soffit of projecting lintel at Hawthorne Avenue viewed from below.

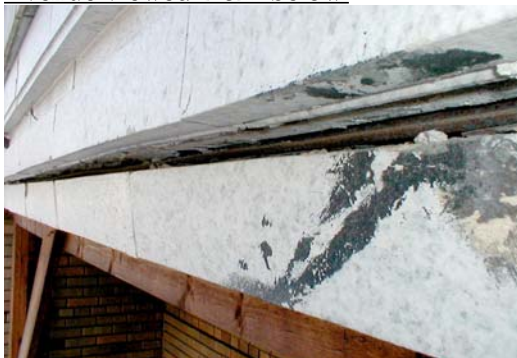
Fig.36: Deflection at lintel steel support visible through open joint between terra cotta soffit and lower band units.

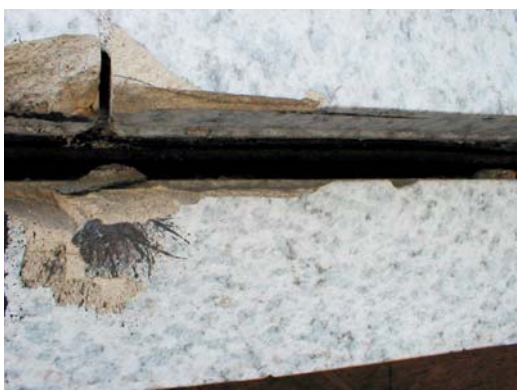
Fig.37: Severely corroded steel support visible through open joint between terra cotta soffit and lower band units .

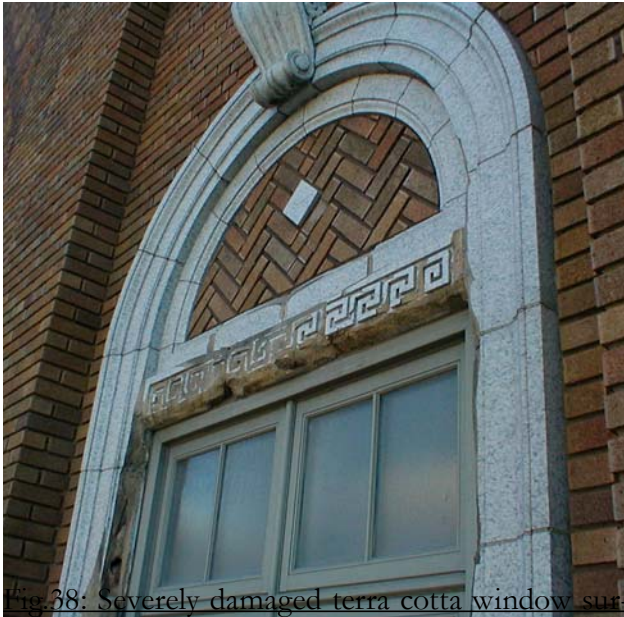
Fig.38: Severely damaged terra cotta window surrounds with exposed core at left jamb. Bay 1, south end

- Terra Cotta: The terra cotta window surrounds at the jambs, Greek key and flat panel lintel units are being replaced entirely with new terra cotta. Many of these units are broken completely through exposing the core and allowing water to freely enter the wall system. This could also be another major source of water penetration into the balcony soffit below.
- Steel Anchorage: There has been no investigation of steel support members to date. The worst case scenario would involve replacement of steel supports at the window jambs or lintels. This would require window removal and shoring of the masonry arch.

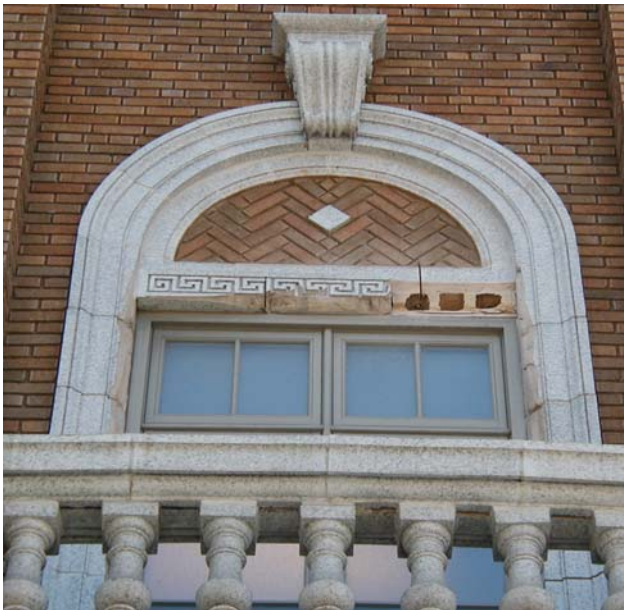
Fig.40: Severely damaged terra cotta window surrounds. The Greek key unit to the right was removed by the contractor and sent to the manufacturer as a template. Bay 2, south end.

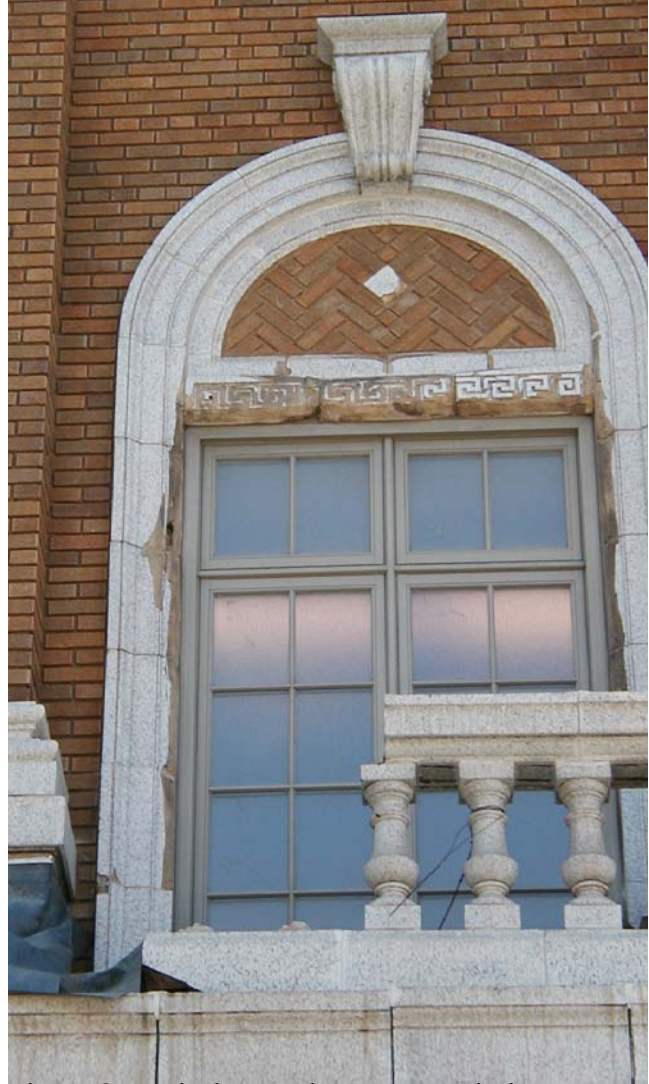
Fig.39: Severely damaged terra cotta window surrounds- Bay 1, south end

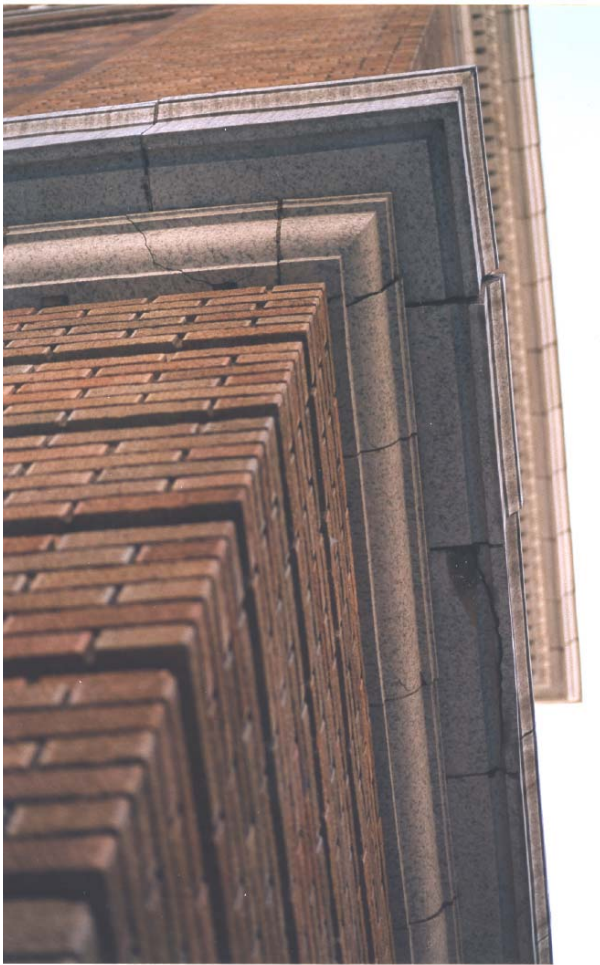
Fig.42: The second dripstone unit is displaced outward indicating that the steel anchors may have broken free and are no longer supporting the unit.

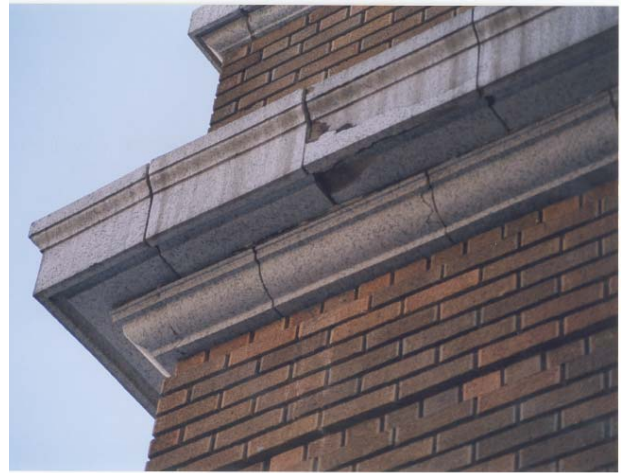
Fig.41: The second dripstone unit is displaced and the third fractured, the fragment ready to fall (Spring 2002)

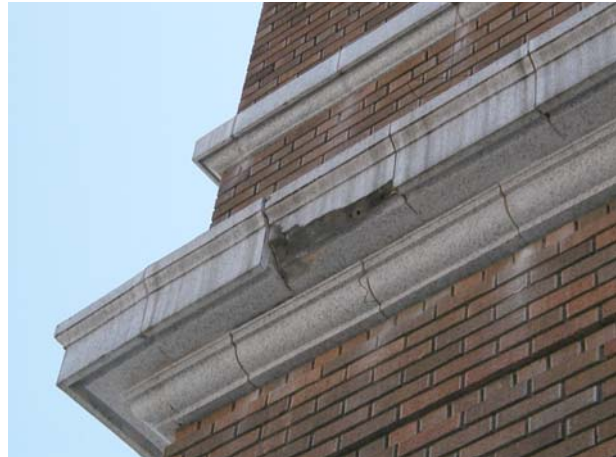
Fig.43: One year later, the fragment has spalled off (Spring 2003)

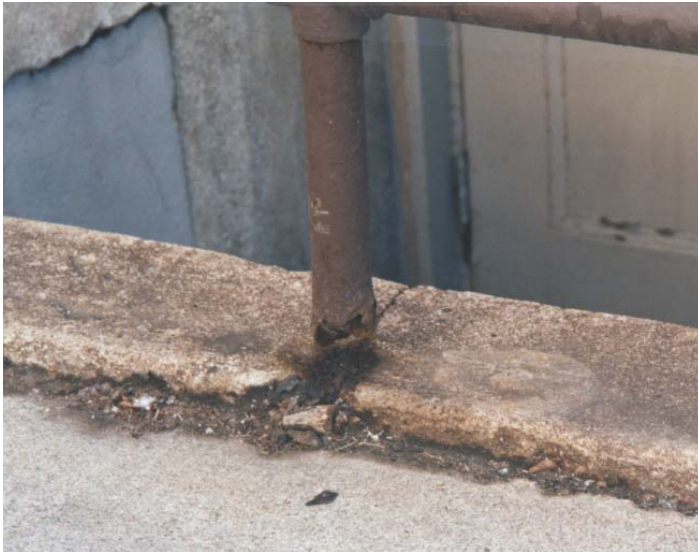
Fig.48: Typical railing support at exit arcaway on Hawthorne Avenue.

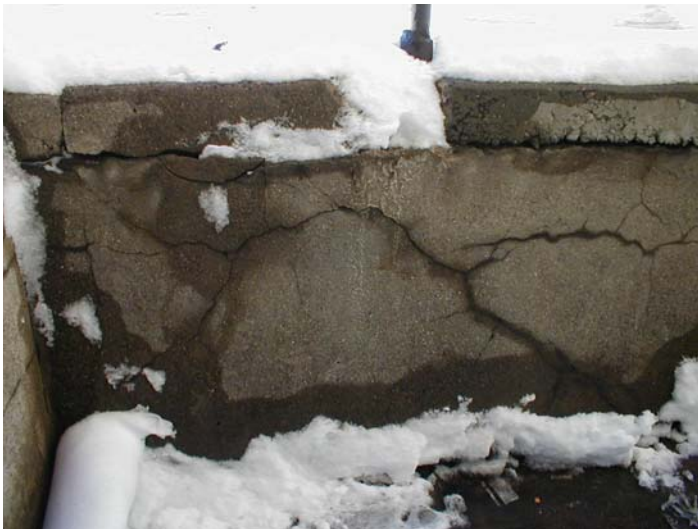
Fig.49: Concrete retaining wall at exit arcaway on Hawthorne Avenue.

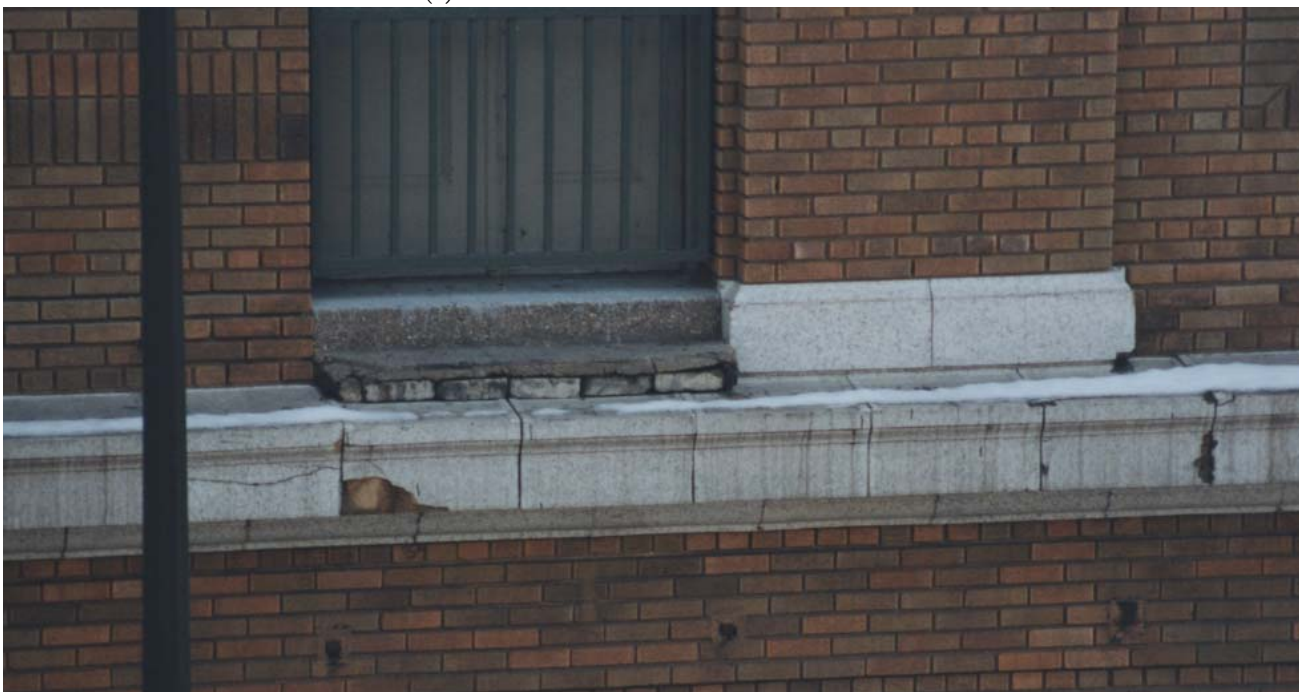
Fig.50: Threshold above dripstone band on Hawthorne Avenue.

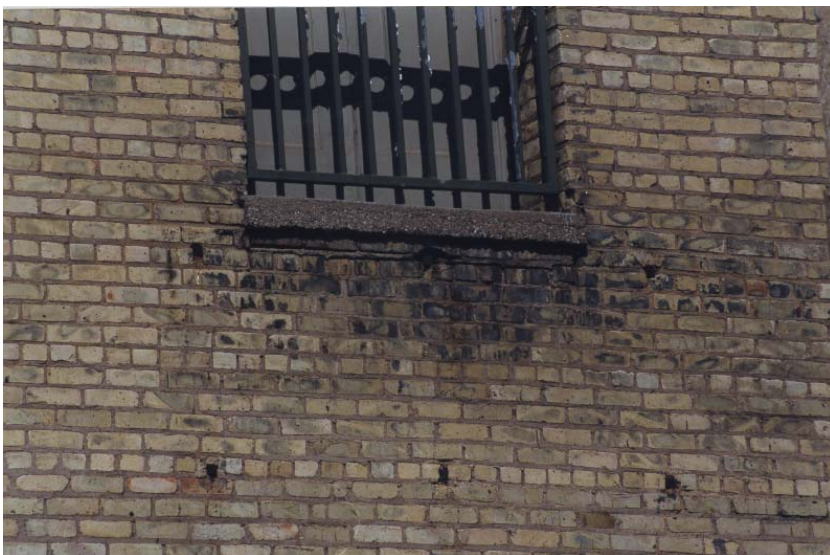
Fig.51: Damaged masonry below threshold at south court. This level of deterioration is typical for all doors on both the Hawthorne Avenue and south court facades.

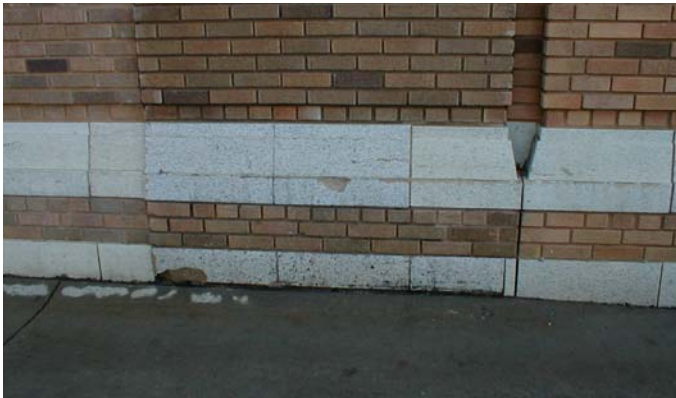
Fig.51: Damaged terra cotta water table along Hawthorne Avenue.
